**Flood Control Project Maintenance  
Levee Inspections****LMA District Cover Sheet****Spring 2015 Levee Inspection Results****Levee District No. 0009 (Sutter County)**

**Levee Inspection Report By Mile - Spring 2015**

Waterway	Bank	Unit Miles	Inspection Start/End	Inspector
Unit No. 01 Sutter County, Feather River	Right	6.25	05/20/2015 05/20/2015	Michael Pitta

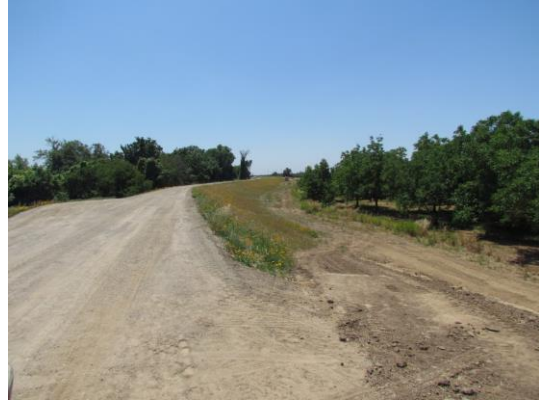
Photo 1 of 1 : SP\_2015\_LD0009\_202\_26\_20150521\_00020.jpg

LM Start	0.01	Rating **	M	Issue No.	26
LM End	6.25	Issue Type +	Ma	Location *	LS
Category	Earthen Levee			GPS Latitude/Longitude	
				Start	End
Item	Vegetation			39.170345 °	39.254369 °
				-121.622532 °	-121.636530 °
DWR ID	DWR_LD0009_01_s_2015_26				
Action/Comments					
Control annual grass and weeds on the levee slopes and easements.

View of the vegetation on the landside of the levee facing upstream.

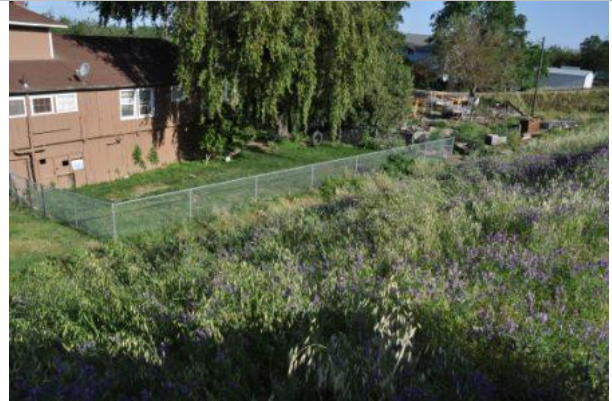
Photo 1 of 1 : SP\_2015\_LD0009\_202\_7\_20150401\_00001.jpg

LM Start	3.05	Rating **	M	Issue No.	7
LM End	3.06	Issue Type +	En	Location *	LS
Category	Earthen Levee			GPS Latitude/Longitude	
				Start	End
Item	Encroachments			39.211052 °	39.211228 °
				-121.628851 °	-121.628808 °
DWR ID	DWR_LD0009_01_s_2012_7				
Action/Comments					
Fence

L/S fence along levee toe.

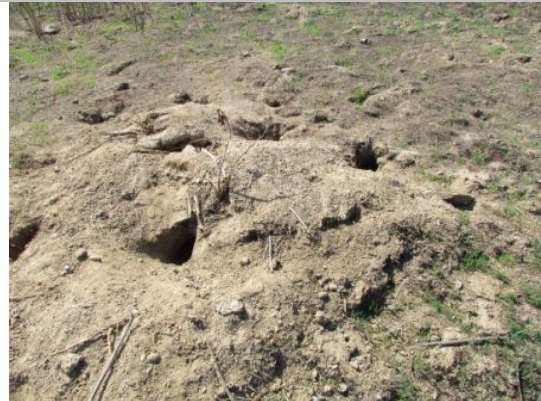
Photo 1 of 1 : SP\_2015\_LD0009\_202\_22\_20150401\_00007.jpg

LM Start	3.10	Rating **	A/W	Issue No.	22
LM End	3.30	Issue Type +	Ma	Location *	WS
Category	Earthen Levee			GPS Latitude/Longitude	
				Start	End
Item	Animal Control				°
					°
DWR ID	DWR_LD0009_01_f_2013_22				
Action/Comments					
No rodents visible, but rodent burrows visible; need to backfill and compact or grout burrows. Inspector Comments: Large burrows on waterward levee slope. Will be repaired when the slurry wall is installed summer 2014.

Photo taken looking south from the toe of the levee at rodent holes on the waterward slope.

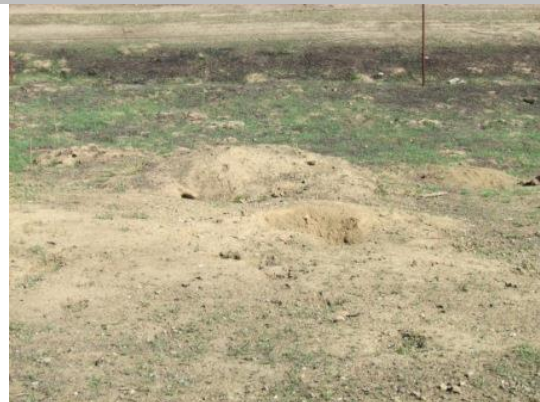
Photo 1 of 1 : SP\_2015\_LD0009\_202\_10\_20150401\_00002.jpg

LM Start	4.69	Rating **	A/W	Issue No.	10
LM End	4.69	Issue Type +	Ma	Location *	WS
Category	Earthen Levee			GPS Latitude/Longitude	
				Start	End
Item	Animal Control			39.234343 °	39.234343 °
				-121.632200 °	-121.632200 °
DWR ID	DWR_LD0009_01_f_2013_10				
Action/Comments					
No rodents visible, but rodent burrows visible; need to backfill and compact or grout burrows.

Photo taken from the levee crown looking east down the waterward slope at rodent holes.

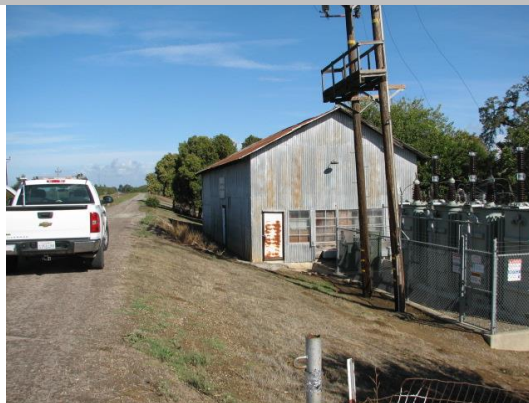
Photo 1 of 1 : SP\_2015\_LD0009\_202\_11\_20150401\_00003.jpg

LM Start	5.68	Rating **	U	Issue No.	11
LM End	5.68	Issue Type +	En	Location *	WS
Category	Earthen Levee			GPS Latitude/Longitude	
				Start	End
Item	Encroachments			39.247697 °	39.247697 °
				-121.637312 °	-121.637312 °
DWR ID	DWR_LD0009_01_s_2012_11				
Action/Comments					
Building

Building at the waterside toe.

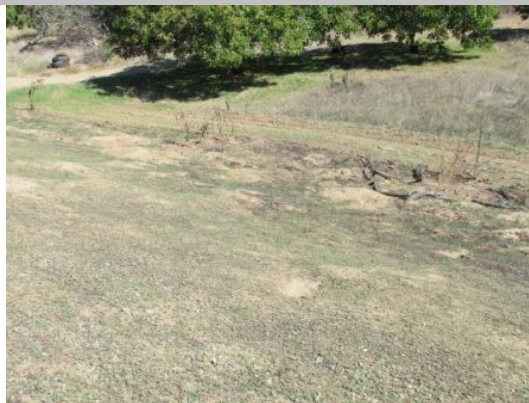
Photo 1 of 1 : SP\_2015\_LD0009\_202\_24\_20150401\_00009.jpg

LM Start	5.76	Rating **	A/W	Issue No.	24
LM End	5.76	Issue Type +	Ma	Location *	WS
Category	Earthen Levee			GPS Latitude/Longitude	
				Start	End
Item	Animal Control			39.248868 °	39.248868 °
				-121.637232 °	-121.637232 °
DWR ID	DWR_LD0009_01_f_2013_24				
Action/Comments					
No rodents visible, but rodent burrows visible; need to backfill and compact or grout burrows.

Photo taken from levee crown looking down waterward slope at rodent holes.

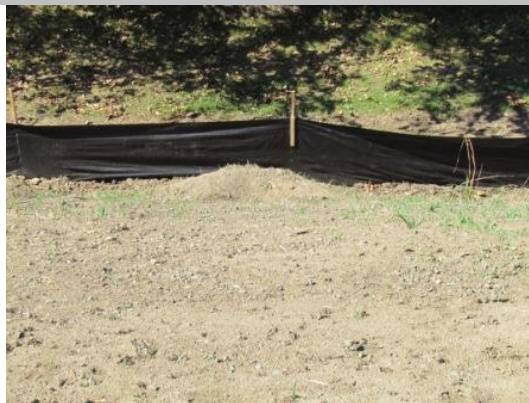
Photo 1 of 1 : SP\_2015\_LD0009\_202\_25\_20150401\_00010.jpg

LM Start	6.14	Rating **	U	Issue No.	25
LM End	6.14	Issue Type +	Ma	Location *	LS
Category	Earthen Levee			GPS Latitude/Longitude	
				Start	End
Item	Animal Control			39.254369 °	39.254369 °
				-121.636531 °	-121.636531 °
DWR ID	DWR_LD0009_01_f_2013_25				
Action/Comments					
No rodents visible, but rodent burrows visible; need to backfill and compact or grout burrows.

Photo taken from levee crown looking west down landward slope at rodent holes.
